WL-TR-91-4049

X-RAY COMPUTED TOMOGRAPHY OF **FULL-SCALE CASTINGS**

October 1991

Interim Report for Period March 1990 to December 1990

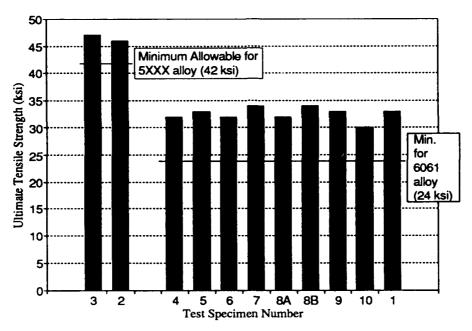
As was discussed in Section 3.1.2, ASTM radiographic standards for casting manufacture are not based upon engineering data. For example, Figure 3.1-5 shows that ultimate tensile strength in welded aluminum alloy tensile specimens is not correlated to the rejection criteria. Welding in these specimens was performed to simulate a casting process and allowed the inclusion of porosity defects [11]. The graph shows that specimens containing rejectable levels of defects always exceed the minimum utlimate strength requirement. The effect of porosity on the mechanical properties of castings has shown mixed results in various studies. McLellan and Tuttle [12] showed that porosity above 19 µm reduced ductility in Al-Si-Mg castings but that the combination of various cell sizes, chemistries and porosity could balance each other to arrive at desired mechanical properties. Eady and Smith [13] concluded that the effect of the porosity (in the range of 60 to 500 µm with percentages from 1 to 7 percent) was not straightforward and could be masked by other variables such as alloy content (Mg, in their study) and dendritic arm spacing. Porosity was found to not always be detrimental but depended on other parameters. As Figure 3.1-6 shows, degradation in tensile strength, for the system studied in reference [11], does not occur below 3 percent void area, which is in the regime of CT measurement sensitivity. Thus, the fine porosity defects should not be a necessary cause for part rejection. Rather, the application of the casting and the size of the defective area should be considered. The ASTM frame number becomes a cosmetic measure which may be useful for evaluating the "goodness" on a subjective qualitative scale of locations which are to be machined or drilled. Unfortunately, with film radiography, the specific three dimensional location of the features cannot be pinpointed to ensure that subsequent machining operations may not intersect the defects.

Figure 3.1-5 Welded Al test specimens with acceptable strength but rejectable radiographic porosity indications per BAC 5975, Class "A" or "B" welds.

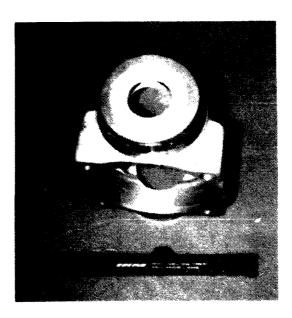
Another example is the 707 flap drive actuator housing casting shown in Figure 3.1-7. This aluminum cast part was fabricated, machined and a brass insert installed. Although the part passed early inspections, after final machining, penetrant inspection revealed potential porosity. The normal disposition of the component would be destructive analysis. However, due to the value of the component, several alternatives were considered to assess the severity of the penetrant indications. Radiographic inspection was very difficult to perform due to the orientation of the defect area and the presence of the brass material. The results were inconclusive, although they did not indicate any severe porosity near the lip of the part. Computed tomography was successfully used to show that the porosity throughout the part was minor. Based on the application of the component, engineers were able to conclude that the part could be safely put into service. The salvaging of the part was directly responsible for over \$10K in cost savings due to the investment in machining, inspection and disposition. But, more importantly, the part was needed for an "aircraft on ground" (AOG) situation (a condition where an aircraft is unavailable for its scheduled mission). The cost of delays for AOG responses are significant in dollars and mission readiness. Computed tomography provided the interpretable evidence of the soundness of the component for service and avoided costly refabrication of the housing.

Figure 3.1-7 Photograph of the 707 flap drive actuator casting.

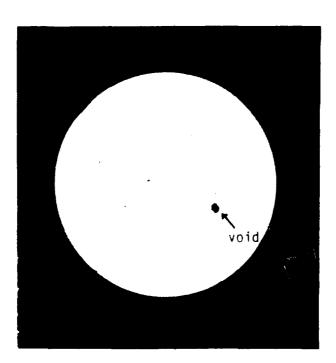
Figure 3.3-2 CT image of aluminum disk showing the large void used for the sensitivity study.

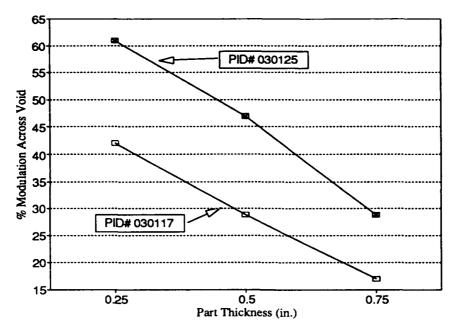
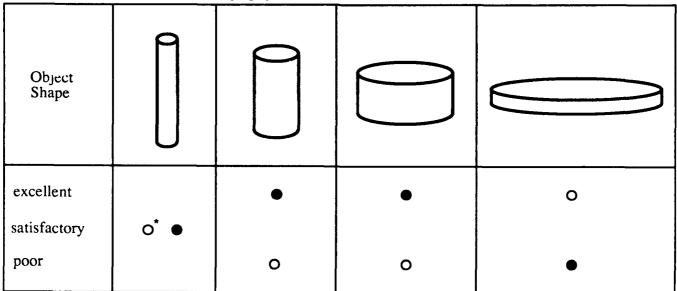
Figure 3.3-3 Graph showing the effect of thickness (path length) on RT defect sensitivity in cast coupons PID# 030117 and 0301125.

These results show that film radiography can become ineffective in defining actual defects in thicker castings. Film works best with thin, flat shapes. Thick objects of complex shape are more effectively inspected with CT. Figure 3.3-4 shows which type of object geometries work best for CT and RT inspection.

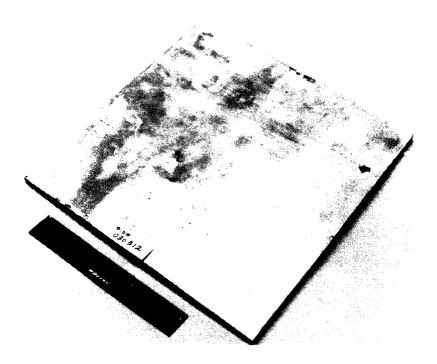
An example of the use of CT for new product development is the titanium alloy test plate (PID# 030312) which was used to study the manufacturing process of this alloy for use in the Advanced Tactical Fighter program (Figure 4.1-1). The particular manufacturing method for this plate produced some large flat voids in the interior of the plate, which were identified with film radiography. The plate was then subjected to hot isostatic pressing (HIP) in order to eliminate the voids. HIP, which involves subjecting a component to a high temperature, high pressure environment, is often used to heal internal porosity in castings. At this point, it was difficult to determine with film radiography how successful the HIP process was. The plate was then scanned with CT at the previous locations of the voids. The CT images indicated not only that some voiding was still present, but showed the actual extent and depth of the remaining voids. Figure 4.1-2 shows a CT slice taken on System L which passes through two voids. This information could then be used to help optimize the process by adjusting the appropriate

Figure 4.1-1 Photograph of titanium alloy test plate.

Figure 4.1-2 CT slice of titanium alloy test plate showing two voids which were not eliminated through the HIP process.

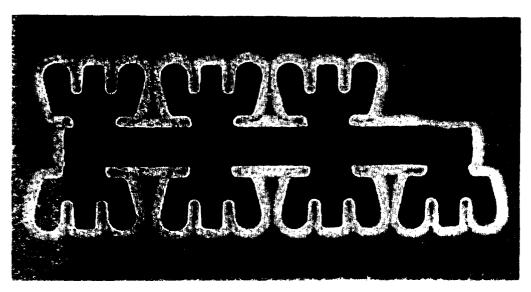
In investment castings, the quality of the product is strongly dependent on the mold condition. It has been estimated that 80 percent of rejections in investment castings can be attributed to problems in the mold. Figure 4.1-3 is a photograph of a typical investment mold. The mold is formed around a wax model using an initial layer of zircon or similar material and then multiple outer layers of silica material. Problems with the initial layer, such as peeling or spalling, will result in problems in the final casting. Figure 4.1-4 is a CT slice of the mold taken on System in This imaging can be used to show how the inner layer is forming and its interaction with outer layers. Any indications of missing material is indicative of a potential problem. CT could be applied in the analysis of problem molds and as a process control tool to assure that molds are being consistently formed with the desired material present.

Figure 4.1-3 Photograph of an investment casting mold.

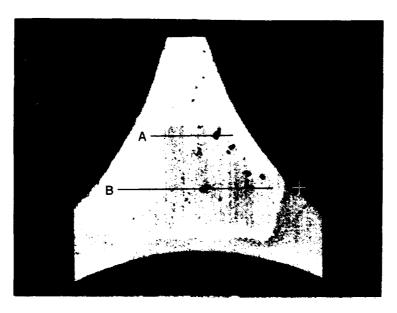
Figure 4.2-2 A digital radiograph (DR) of a section of the sector casting showing porosity. Some CT slice locations are indicated.

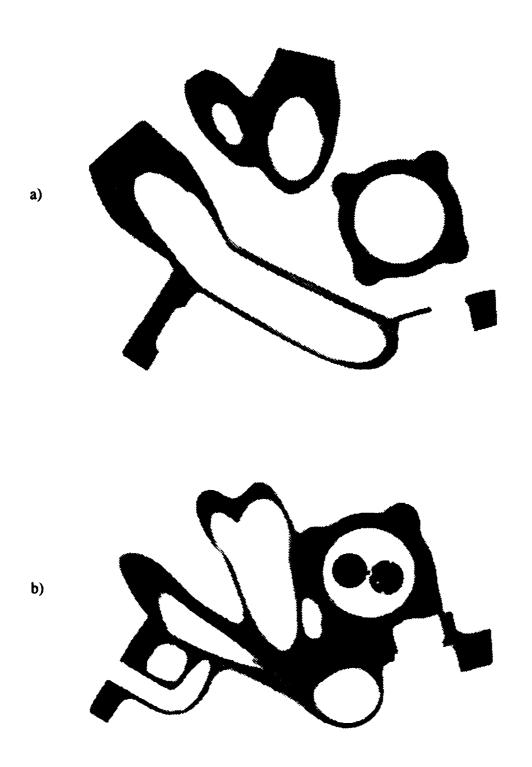
Figure 4.3-3 CT examination of reservoir manifold a) at height 509 mm, b) at height 529 mm.

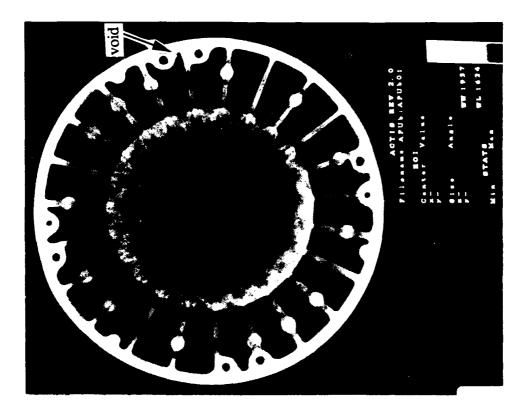
Figure 4.3-4 CT slice of lower pedestal of turbine rotor mount.

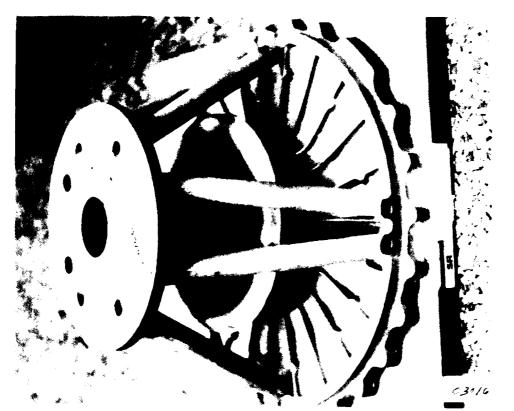
The turbine rotor mount for the 757 auxiliary power unit (APU) (PID# 030166) is shown in Figure 4.3-4. Due to its complexity, a large number of film shots are required to assess the quality of the entire part. It remains questionable whether or not a part of this shape can be truly 100 percent inspected by radiography to appropriate quality levels, or whether that requirement is necessary. Figure 4.3-5 is a CT slice taken on System L through the lower pedestal, which reveals a defect whose location would make it difficult to "see" or to assess with film radiography. The location and extent of this defect is defined in this CT image. CT simplifies the assessment of defects in complex components.

Figure 4.3-4 Photograph of APU turbine rotor mount.
